JOURNAL OF THE GEOTECHNICAL ENGINEERING DIVISION

REMEDIAL TREATMENT EXPLORATION, WOLF CREEK DAM, KY

By Marvin D. Simmons¹

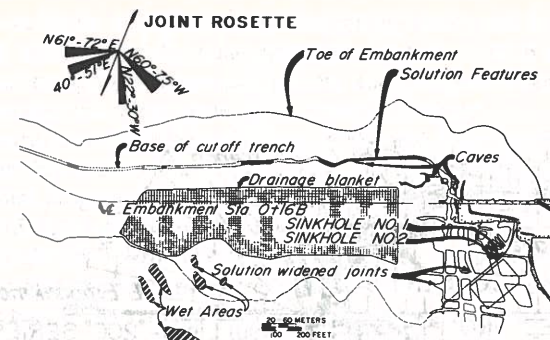
FIG. 4.—Plan of Features in Embankment Foundation and Wet Areas

Sinkhole.—On March 13, 1968, a sinkhole developed near the downstream toe of the embankment where it wrapped around the concrete section of the dam (Fig. 4). At first, the sinkhole was only about 2 ft (0.6 m) in diameter at the surface, and 6 ft (1.8 m) deep, but in continued to develop until it was 13 ft (4 m) in diameter and 10 ft (3 m) deep (6).

A second sinkhole occurred on April 22, 1968, about 40 ft (12.2 m) away

from the first (Fig. 4). There was no warning of the occurrence of this second sink. In fact, a drill rig had sampled the soil to the top of rock at this location the day before and there had been no indication of disturbance of the fill or natural overburden materials. At about the same time as the occurrence of the second sink, muddy water could be seen in the tailrace with the generators operating.

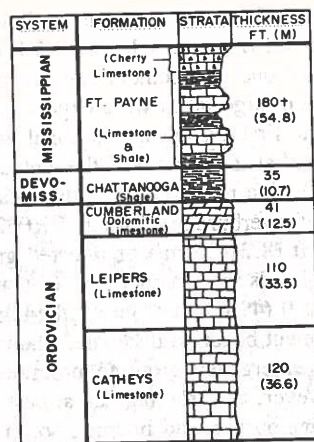
FIG. 6.—Generalized Geologic Column at Wolf Creek Dam

Originally, the wall was to be constructed to a depth of 5 ft (1.5 m) (a depth that appeared to be below all solution activity) into the Catheys Formation (Fig. 6), and from the concrete section toward the right abutment, a distance of over 3,000 ft (915 m). Ultimately, the depth of the bottom of the wall varied in elevation depending on conditions encountered during explorations. Linear ele-

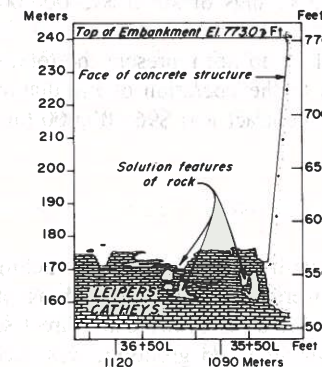
FIG. 7.—Section along Diaphragm Wall Alignment Showing Solution Features of Bedrock

A total of 852 holes were drilled along the alignment; most of them were cored with NQ wireline tools at the election of the drilling contractor. Fifty-one holes took over 1,000 cu ft (28 m³) of grout before refusal; the maximum grout injected into any hole in rock was 6,971 cu ft (195.2 m³). The total footage drilled was 239,460 ft (73,035 m), and the total grout injected was 146,461 cu ft (4,100 m³), for a unit take of 0.61 cu ft/lin ft (0.056 m³/m) of hole. Although these quantities indicated the overall condition of the embankment and its foundation, when the details of the program were studied, the different conditions at specific reaches could be identified. An example of some of the more serious solution features encountered in rock along the alignment are shown on the geologic profile (Fig. 7).
