JOURNAL OF THE GEOTECHNICAL ENGINEERING DIVISION

Lateral Loading of Deep Foundations in Stiff Clay

By H. Bolton Seed,¹ Kenneth L. Lee,² Izzat M. Idriss,³ Members, ASCE,
and Faiz I. Makdisi,⁴ A. M. ASCE

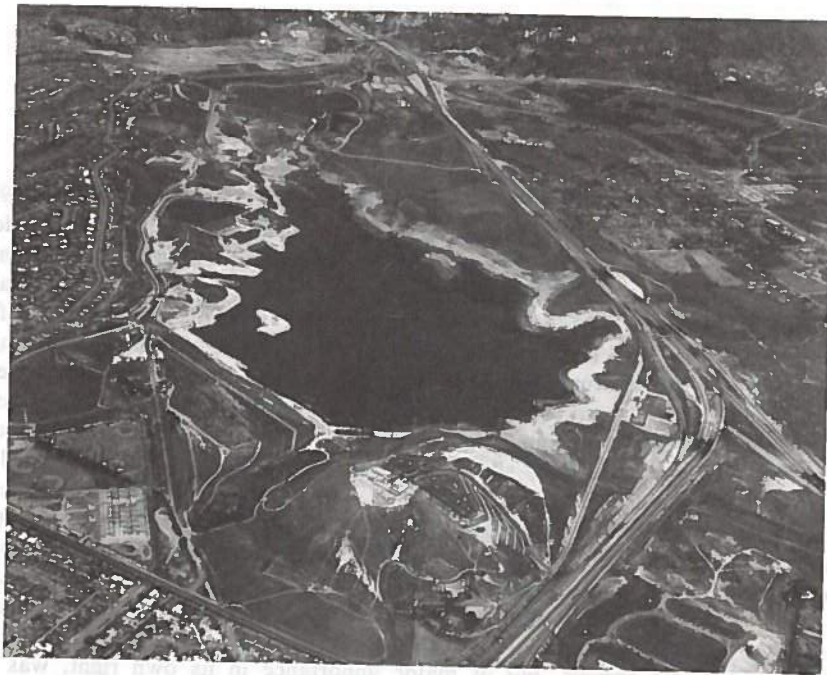
The downstream movement of the Upper Dam led to some cracking of the embankment, opening up of joints in the outlet conduit through the embankment, and the formation of a sink-hole along the line of the conduit due to erosion through the joints. However, although the crest moved downstream about 5 ft (1.5 m) and settled about 3 ft (0.9 m) there was no breach, resulting in loss of water from the reservoir. If this had not been the case and water from

FIG. 1.—Aerial View of Van Norman Lake Complex Taken after Earthquake (Department of Water Resources)

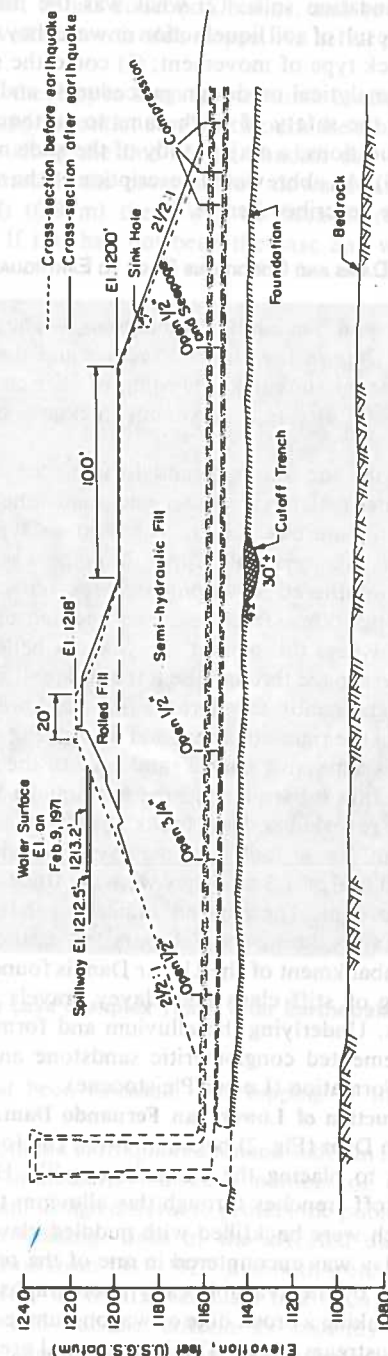
FIG. 3.—Cross Section of Upper San Fernando Dam (Los Angeles Department of Water and Power) (1 ft = 0.305 m)

to the surface and its location is indicated on Fig. 3 almost directly above an open crack in the conduit. It was apparently formed by seepage and erosion through the cracks in the conduit during or immediately following the earthquake.

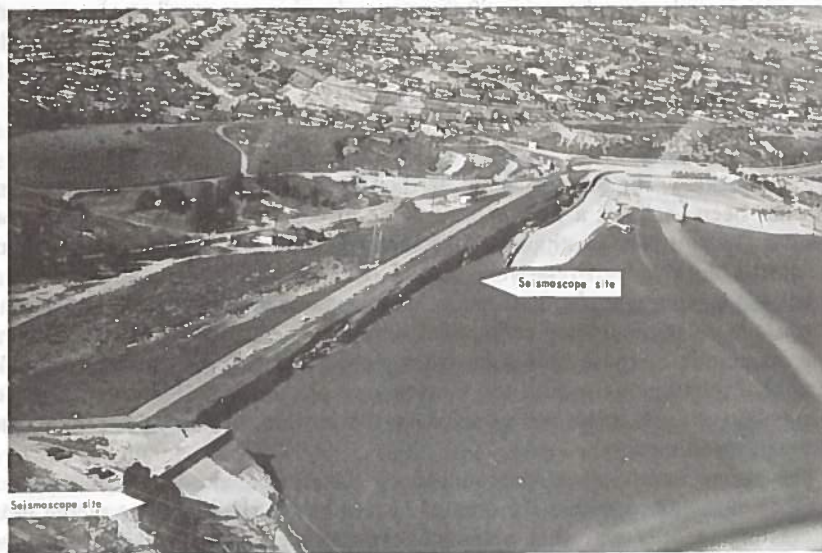
FIG. 4.—Aerial View of Lower San Fernando Dam after Earthquake of February 9, 1971 (Arrows Indicate Seismoscope Sites) (United States Geological Survey)

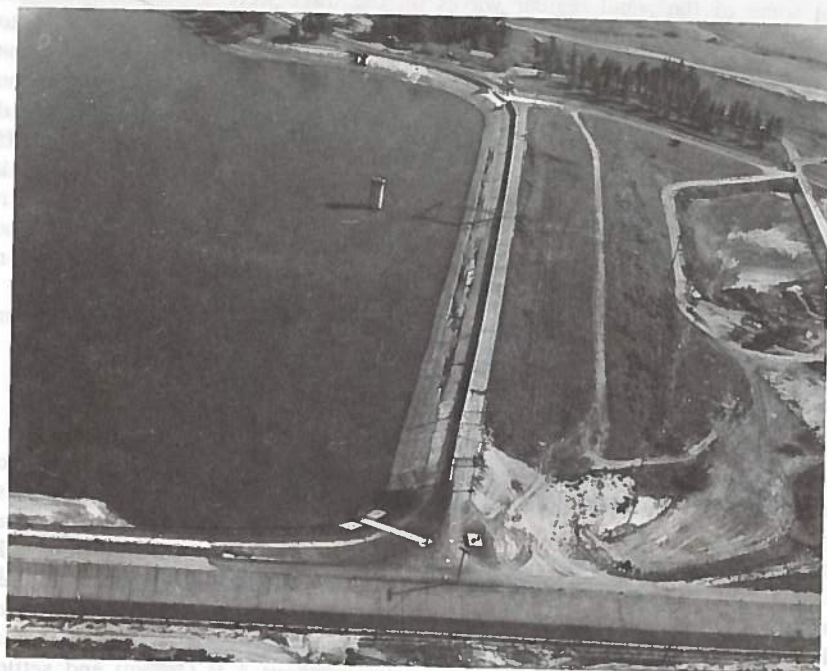
An aerial view of the Upper Dam taken about 12 days after the earthquake is shown in Fig. 6. Severe longitudinal cracks are clearly evident running almost the full length of the dam on the upstream slope. At the time of the earthquake, the water level in the reservoir was above these cracks so that they were only visible after the reservoir level had been drawn down. These cracks resulted from a general downstream movement and settlement of the top portion of the dam with respect to the foundation. Subsequent surveys showed that at the center line, the crest moved downstream about 5 ft (1.5 m) and settled vertically about 3 ft (0.9 m) (Fig. 3).

FIG. 6.—View of Upper San Fernando Dam after Earthquake (Department of Water Resources, February 21, 1971)

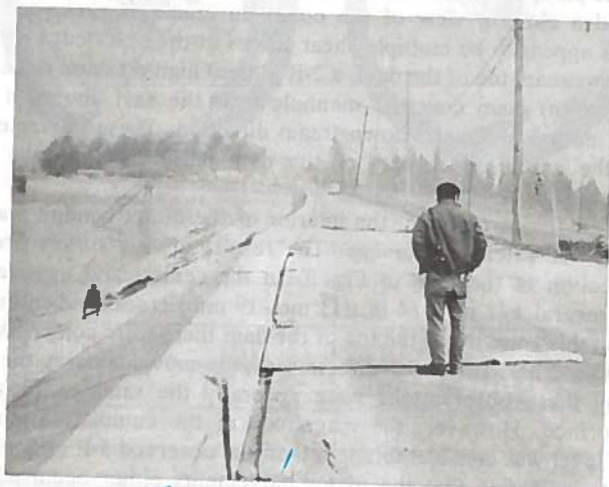
A closeup view from the ground along the crest of the dam showing the bowing of the parapet wall resulting from the downstream movements is shown in Fig. 7 and a closeup view of the upstream cracks is presented in Fig. 8. These cracks appear to be multiple shear scarps at the outer edge of the fill.

FIG. 7.—Deformation of Parapet Wall Resulting from Downstream Movement of Embankment

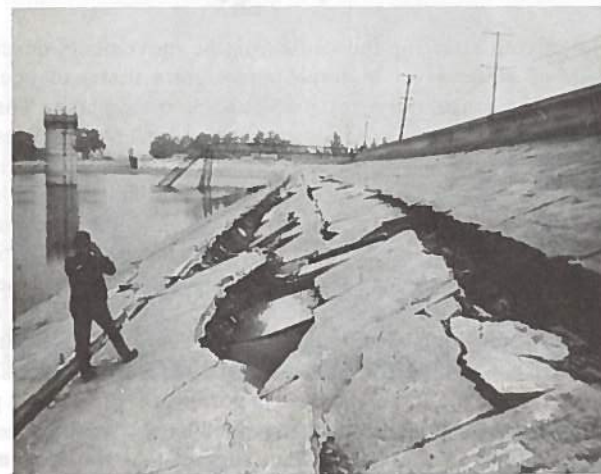
FIG. 8.—Slide Scarps on Upstream Face of Embankment

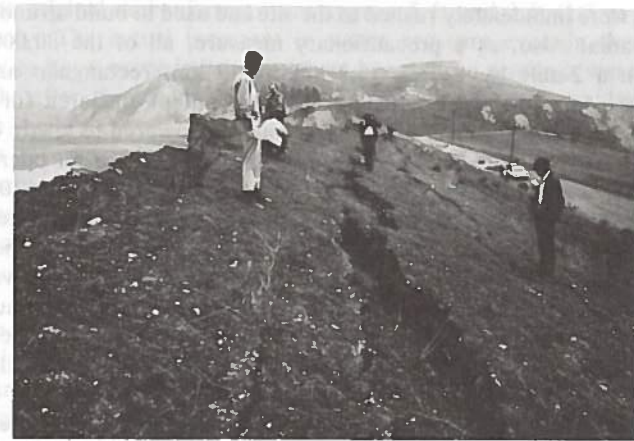
At the lowest point of the embankment, the water level in the reservoir was only about 5 ft (1.5 m) below the sharp crest of the remaining near-vertical scarp. Numerous large longitudinal cracks had developed behind the scarp at lower elevations offering a potential for still further sliding that could reduce

FIG. 10.—Longitudinal Cracks in Remaining Portion of Embankment, Lower San Fernando Dam

or eliminate the meager precarious freeboard that remained. Some of these cracks are shown in Fig. 10.

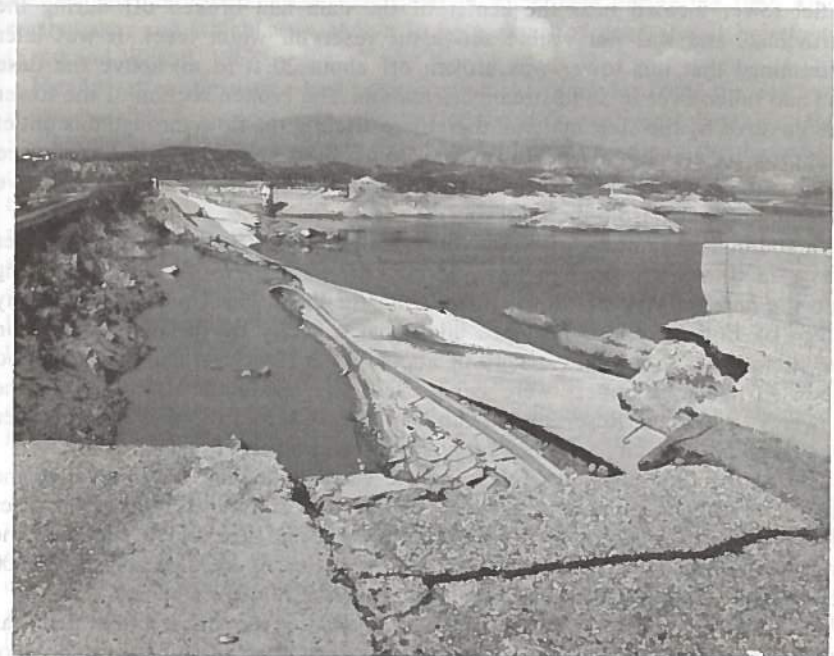
FIG. 11.—Slide Damage to Lower San Fernando Dam (Department of Water Resources, February 22, 1971)

As the reservoir drained, the full extent of damage to the dam became increasingly apparent. A photograph of the dam taken about 13 days following the earthquake is shown in Fig. 11. By this time the water level had been lowered about 31 ft (9.5 m). Much of the slide debris was then visible. The original upstream sloping face of the dam was paved with concrete and sloped at 2-1/2 horizontal to 1 vertical. As shown in Fig. 11, this upstream slope had moved out horizontally into the reservoir, dropped considerably in elevation, and was lying almost horizontally.

As soon as possible following the quake, all the inflow to the reservoir was turned off and the outflow was increased to the maximum possible rate. Fortunately, the outlet tower near the west abutment remained standing and was not damaged during the earthquake although the walkway leading from the crest of the dam to the tower was broken during the slide. However, the outlet tower located near the center of the dam had broken off during the earthquake and was not visible above the reservoir water level. It was later determined that this tower was broken off about 20 ft (6 m) above the base and had fallen over in an upstream orientation. The broken section of the tower was covered by the slide material thereby restricting the flow through this outlet to approx 100 cfs (2.8 m³/s). However, within a short period of time the entrance to the tower had cleared sufficiently by erosion and the outlet was quite effective in removing water from the reservoir.

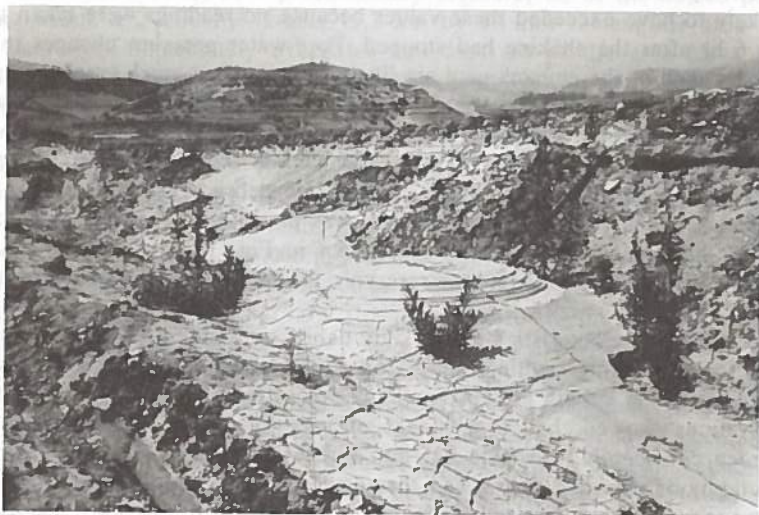
Finally, after the water had been completely removed from the reservoir, it was possible to inspect other portions of the slide near the toe of the debris. Sand boils such as those shown in Fig. 12 were found in some of the depressions or grabens in the lower portions of the slide. A view of the extreme toe of the slide is shown in Fig. 13. The lighter-colored material on which the two men are standing is the toe of the main embankment soil. It is a fine silty sand that appears to have flowed out over the darker-colored silts that had collected in the bottom of the reservoir during the 60 yr of operation. The toe of the slide did not take the form of a pressure ridge that is typical of the more conventional type of landslide.

FIG. 12.—Sand Boils in Depression Scarps near Toe of Slide Debris, Lower San Fernando Dam

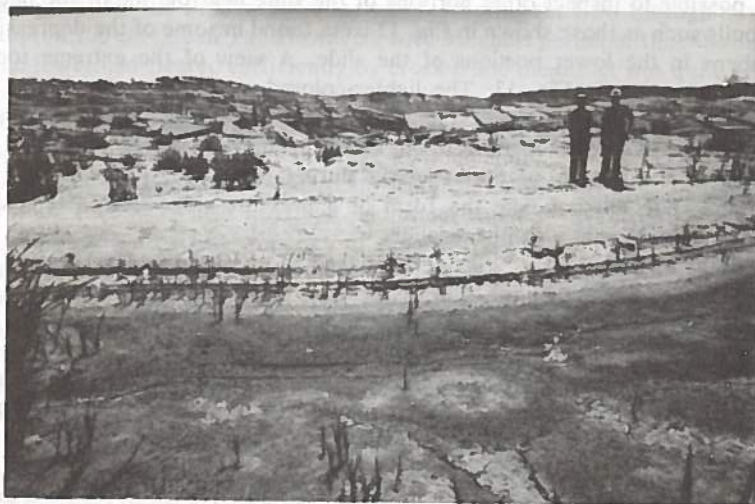
FIG. 13.—Toe of Slide Debris, Lower San Fernando Dam

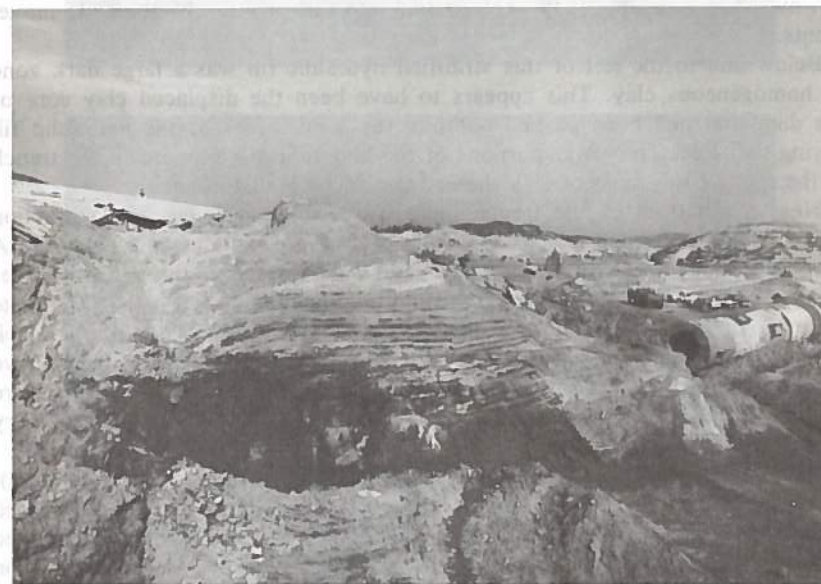
FIG. 14.—Test Strength through Portion of Slide Debris, Lower San Fernando Dam

the embankment to permit examination of failure zones or surfaces that developed during the sliding. Accordingly, a large trench was excavated into the slide debris on the upstream face at about the position of the central tower that had failed during the earthquake. A photograph of the western face of this trench is shown in Fig. 14. The maximum depth of the trench was about 60 ft (18 m) and the base was still about 20 ft (6 m) above the top of the alluvium.

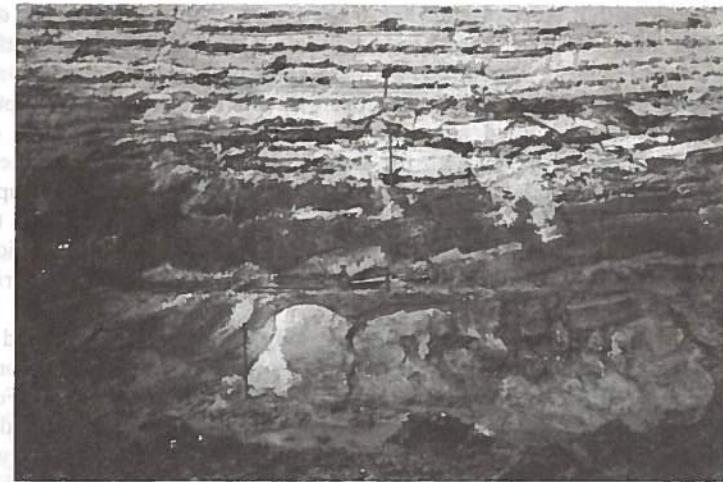
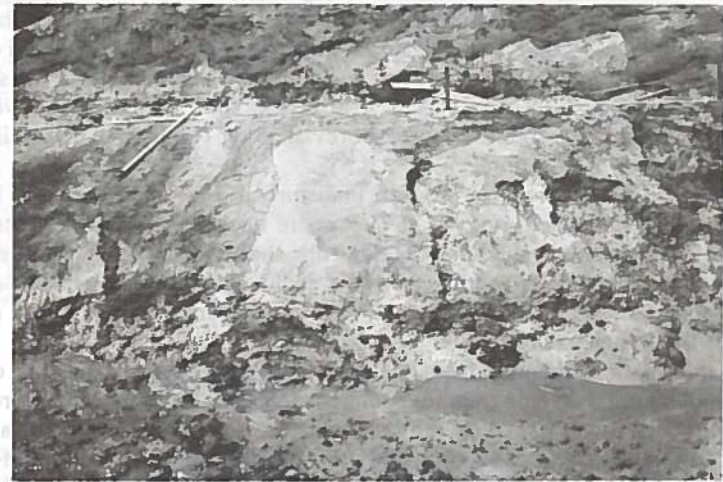
Near the bottom of the trench there was strong evidence of liquefaction of the sandy materials. A closeup view of this area is shown in Fig. 15. A vertical tongue or dyke of light-colored sand had extruded up through the darker soils, producing a configuration that could only have occurred if the sand dyke were moving as a fluid. Had there been a very shallow overburden of soil at this site, it is quite possible that the light-colored sand dyke would have reached the surface and formed a sand boil. It will be recalled that boils were found near the upstream toe of the debris where the overburden was very thin (Fig. 12).

FIG. 15.—Enlarged Views at Bottom of Test Trench in Fig. 14
