JOURNAL of the
Soil Mechanics
and Foundations
Division

Page
Load Transfer in End-Bearing Steel H-Piles by E. D'Appolonia and J. P. Romualdi	1
Effective Stress Theory of Soil Compaction by Roy E. Olson	27
Flexibility of Clay and Cracking of Earth Dams by G. A. Leonards and J. Narain	47
(over)

Although many soils and foundation features of the Oahe Dam will be mentioned herein, only the design of the embankment and cut slope stability will be examined in detail.

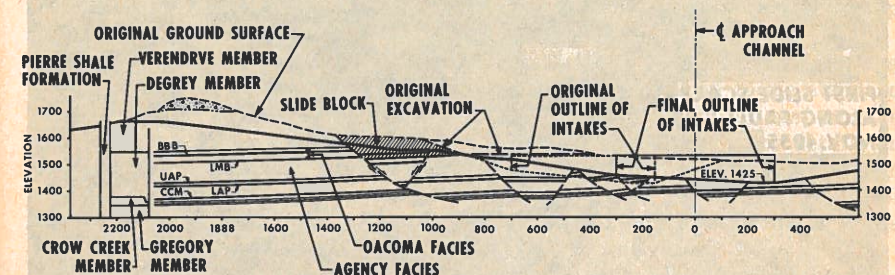
FIG. 5.—SLOPE LANDWARD FROM OUTLET WORKS INTAKES

Explorations following the beginning of the slide showed the slide block was bounded in the rear by an old fault plane and was based along weathered bentonite seams in the Oacoma facies of the DeGray member of the shale formation. The slide surface along the steeply dipping fault was partially smeared with yellow, weathered bentonite and the depth of weathering extended below the base of the slide zone. Because the slide was moving at a slow creep (approximately 1.3 in. per day for first 10 days), the safety factor for the slide was taken equal to unity and, by stability analysis using the modified wedge method, the effective shear strength along the slide plane was computed.

tive or lower shear strength values are desired. Although several combinations of cohesion and friction were determined, the adopted values were cohesion equal to 0.15 ton per sq. ft and a tangent $\phi = 0.15$ ($\phi = 8.5^\circ$). Undisturbed box samples were obtained from the bentonite bed along the slide plane. These samples were tested by both direct shear and squeeze tests for shear strength determination. The results from direct shear tests checked the adopted values closely; the squeeze tests showed slightly less strength.

Slide movement of the lower slide was stopped completely in November 1950, but resumed again the following spring. This was believed due to considerable snow melt and rainfall, so the logical remedy was to try drainage by nearly horizontal drain holes located at the toe of the slide. Although the slide had practically stopped by the time the horizontal drains were installed in 1953, it was possible by alternating plugging and opening the drain outlets to determine that a definite beneficial effect on the stability could be realized from the drainage system. This effect would not have been apparent had not the safety factor of the slope been near unity.

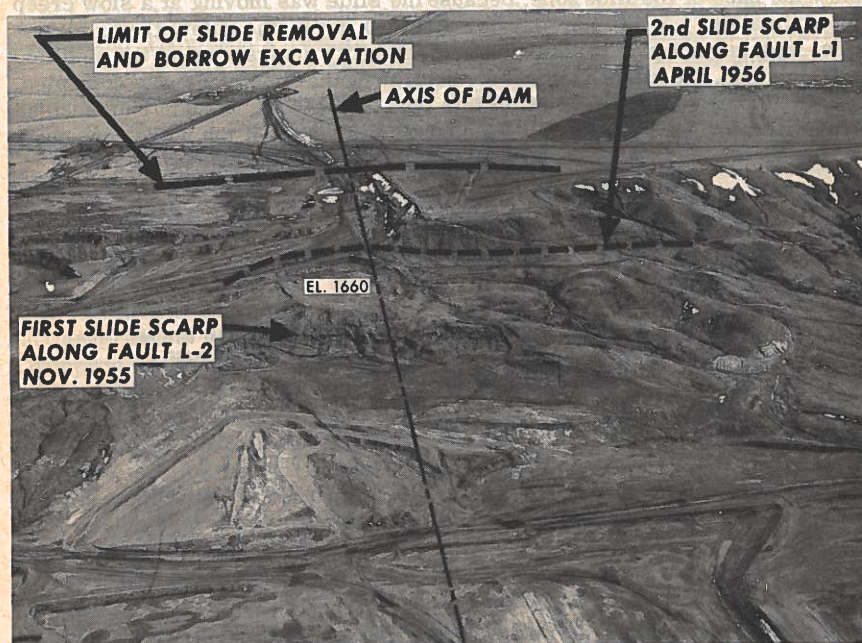
FIG. 6.—AERIAL VIEW OF SLIDE, LEFT ABUTMENT, MARCH 20, 1956

Major Slide Activity began on November 18, 1955, in the central area of the left abutment. An aerial photograph, Fig. 6, shows the area the next spring before any slide excavation operations had begun. When the slide began, the earthwork stage IV contractor had done the first summer's work on the left side of the channel closure section. Among other things, this included the dewatering of an area approximately 400 ft out from the left bank of the river and 2,500 ft upstream and downstream. This was to permit removal of weathered shale foundation material and inspection to insure that firm shale bedrock was reached in the stripping operations. This area is shown on Fig. 9.

Based on observations of field geologists, the initial displacement was an instantaneous rupture, even though a rather large movement continued for several days. The rapid displacement was approximately 5 ft horizontally and 22 ft vertically and covered an area one-fifth of a mile parallel to the abutment slope and one-quarter of a mile wide. The rate of movement immediately following the initial slump was approximately 4 ft per day. The rate decreased gradually until, a month later, it was less than 1 in. per day and, by late January of 1956, almost all appreciable movement had ceased.

The slide was attributed to the stripping excavation at the toe of the abutment and to the previously unsuspected highly weathered condition of the abutment bedrock. There was also an unknown adverse effect from extensive overburden prewetting operations on top of the abutment, which had been going on for 7 months prior to the slide. It is noted that no prewetting of excavation areas was permitted in subsequent operations. Moreover, more stringent controls with regard to the requirement of excavating from the top down were put into effect.

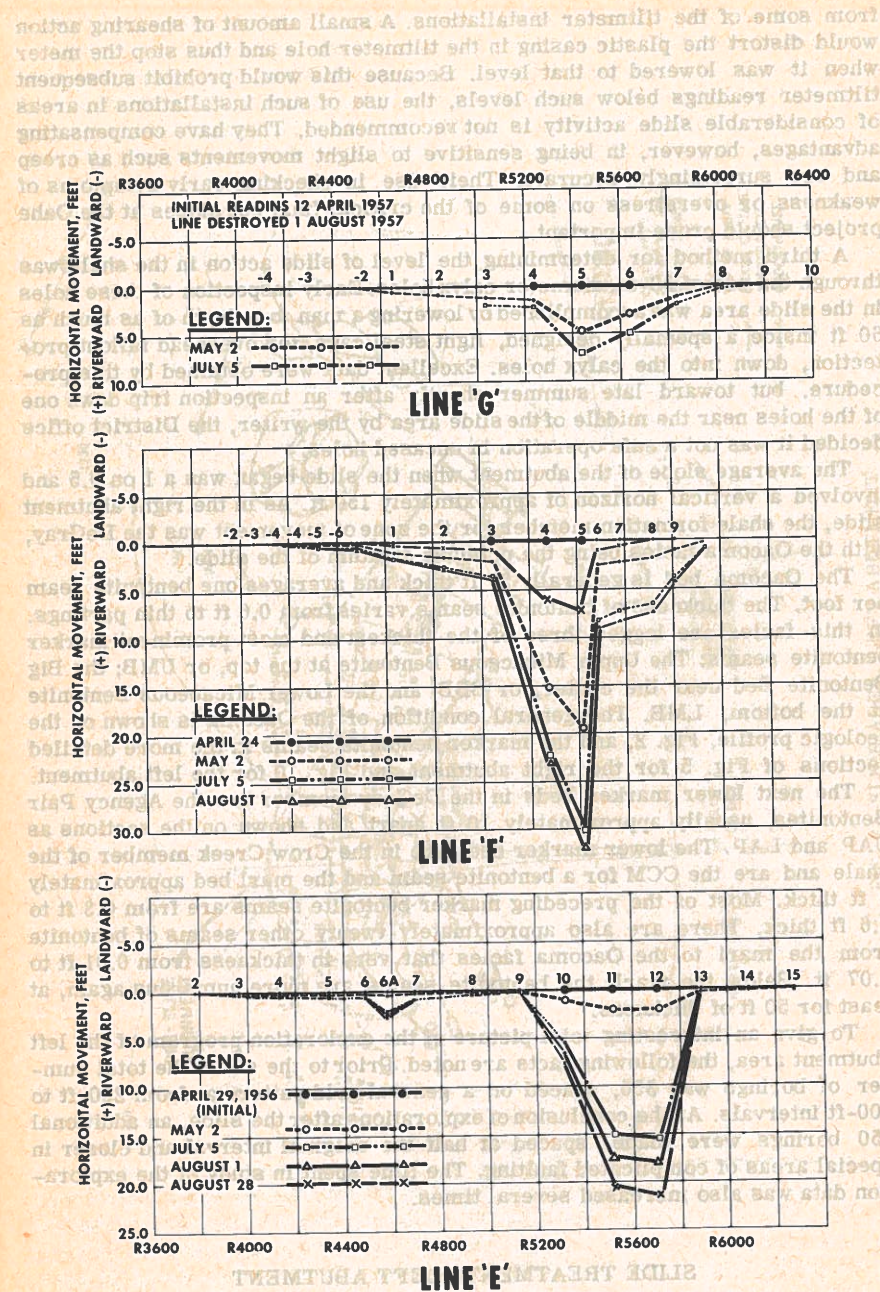
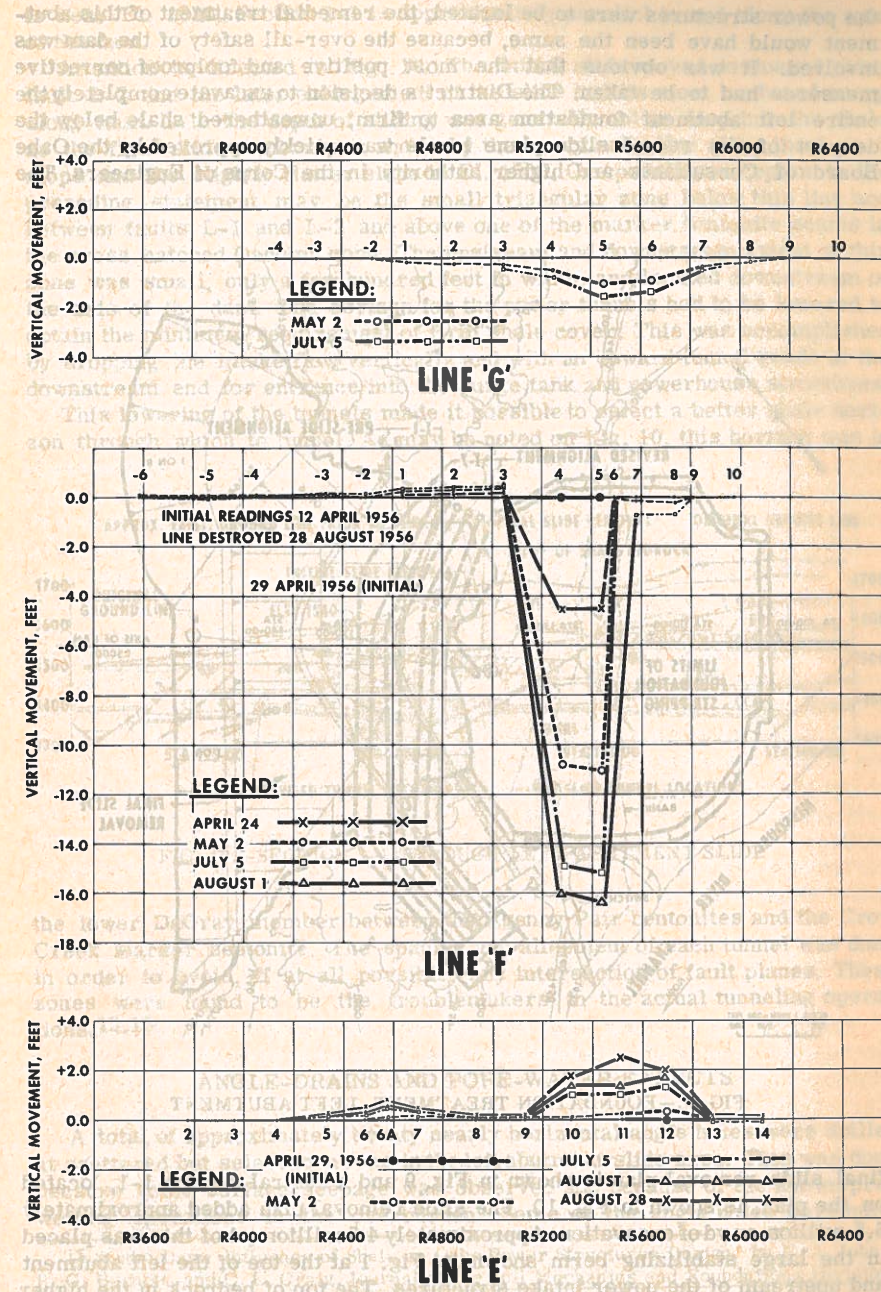
Study of these points and plots of movements as shown on Fig. 8(a) and 8(b) shows that the most active sliding had occurred in a rather narrow band along a center line passing through point 5 in line G and a point midway between points 10 and 11 in line E. This zone of major sliding shows a maximum horizontal movement of 30 ft during the 4 summer months observed.

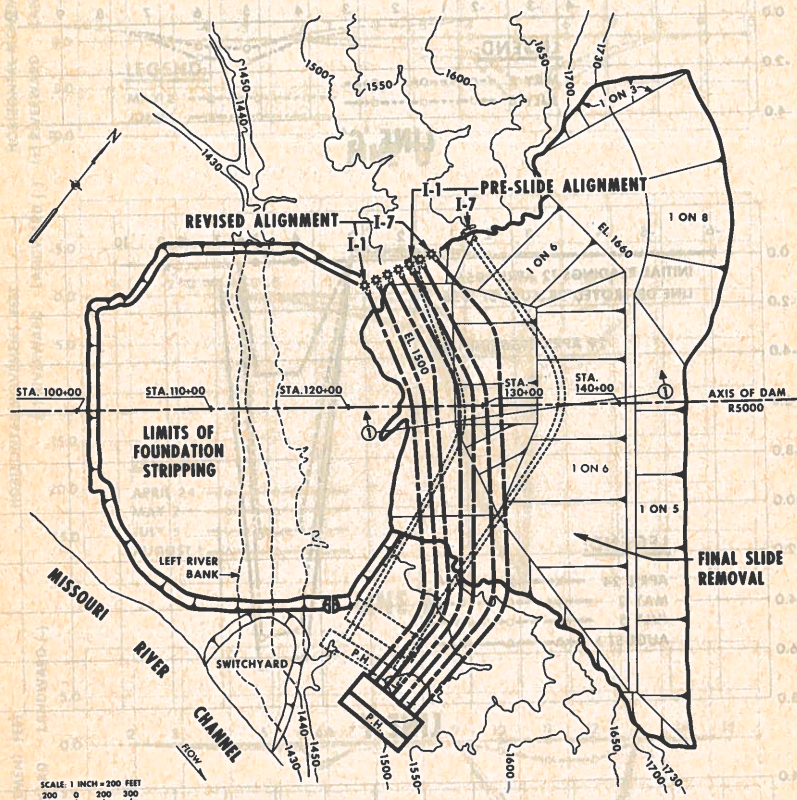
FIG. 9.—FOUNDATION TREATMENT, LEFT ABUTMENT

final slide removal plan is shown in Fig. 9 and a central section 1-1, located on the plan, is shown in Fig. 10. The slide removal plan added approximately 6.5 million cu yd of excavation. Approximately 4.5 million yd of this was placed in the large stabilizing berm shown in Fig. 1 at the toe of the left abutment and upstream of the power intake structures. The top of bedrock in the higher part of the left abutment varied considerably. Immediately downstream of the dam it is lowest at about El. 1550 or 1570, whereas, upstream of the dam, it

the power structures were to be located, the remedial treatment of this abutment would have been the same, because the over-all safety of the dam was involved. It was obvious that the most positive and foolproof corrective measures had to be taken. The District's decision to excavate completely the entire left abutment foundation area to firm, unweathered shale below the deepest of the recent slide plane levels was quickly approved by the Oahe Board of Consultants and higher authority in the Corps of Engineers. The

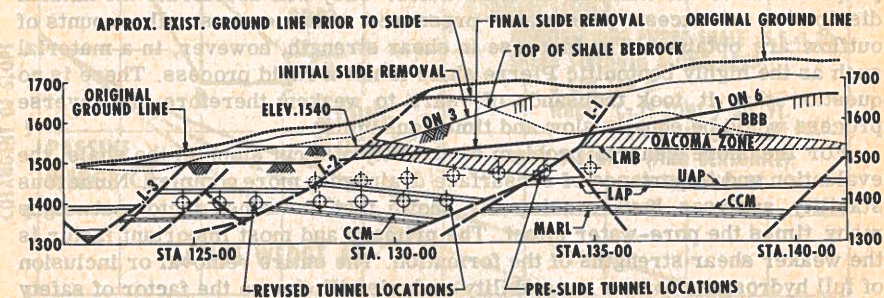
FIG. 10.—SECTION 1-1 THROUGH LEFT ABUTMENT SLIDE

Attention is directed to Fig. 10. The initial slide moved downward along fault L-2 and the later enlargement of the slide had its most landward scarp along fault L-1. The depth of sliding was generally not as deep into the shale as the final slide removal cut shown by the heavy solid line along the 1 on 6 slope and the slightly flatter slope to El. 1500. One possible exception to the preceding statement may be the small triangular zone below this line and between faults L-1 and L-2 and above one of the marker bentonite seams in the cross-hatched Oacoma zone. The upstream and downstream extent of this zone was small, only a few hundred feet in width, and located downstream of the axis of the dam. The horizon for the power tunnels had to be lowered to obtain the minimum requirement of firm shale cover. This was accomplished by dropping the intake flow vertically and with an upward tunnel grade at the downstream end for entrance into the surge tank and powerhouse structures.

This lowering of the tunnels made it possible to select a better shale horizon through which to tunnel. As may be noted on Fig. 10, this horizon was in

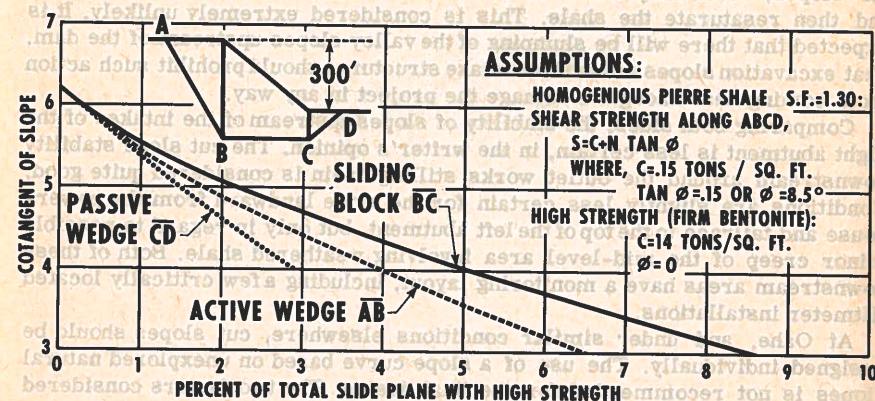
FIG. 11.—STABILITY STUDY

analysis into the active wedge AB, the sliding block BC, and the passive wedge CD. Along the ordinate scale, note that the intercept shows the 300-ft cut could be a 1 on 6.2 slope assuming all of the slide plane strength to be the low values derived from the Oahe slides.

Suppose that somewhere along the slide plane ABCD there were a small irregularity or jog in the surface that mobilized a small zone of high strength. For the present study, assume this high strength to equal that determined by Casagrande for firm bentonite. By following the solid curve to the point corresponding to only 5% of the total slide plane having this high strength somewhere under the sliding block BC, the 300-ft cut now is equally safe at a 1 on 4 slope. This is believed to be a good illustration of what actually happens in the Pierre shale. The deeper the slide plane is into the firm shale, the more appropriate it is to assume a large percentage of high strength to be acting. Because of the complex condition existing in the Pierre shale, it is believed that the study is significant. It first leads to the conclusion (stated previously) that is similar to that stated by Binger and Thompson.¹⁴ It also

reveals the possible range of error in trying to establish a slope chart curve for the design of cut slopes in a formation similar to the Pierre shale.
