JOURNAL OF THE SOIL MECHANICS AND FOUNDATIONS DIVISION

FAILURE OF COLLUVIAL SLOPE

By James V. Hamel,¹ A. M. ASCE and Norman K. Flint²

REFERENCE: Hamel, James V., and Flint, Norman K., "Failure of Colluvial Slope," *Journal of the Soil Mechanics and Foundations Division*, ASCE, Vol. 98, No. SM2, Proc. Paper 8731, February, 1972, pp. 167-180

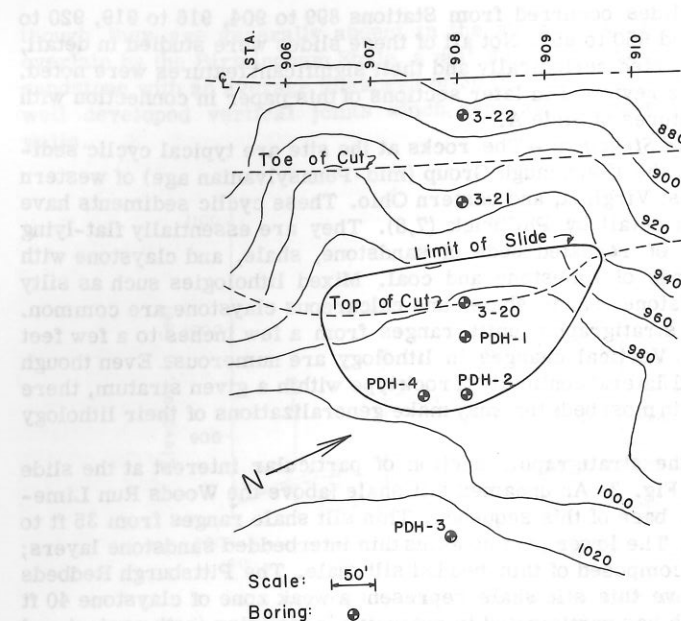
FIG. 2.—PLAN OF SLIDE A

Construction of this section of I-279 began in the autumn of 1968. Slides began soon after slope excavation commenced at several sidehill cut sections on the east wall of the valley between Station 899 and Station 955. Slide A, a typical slide described herein, was located between Station 906+50 and Station 909+50 (see Fig. 2).

The slide outline shown in Fig. 2 is that of February, 1969. Slide material began falling to the bench at El. 900 in appreciable quantities at that time. Movement of Slide A continued at least through November, 1969.

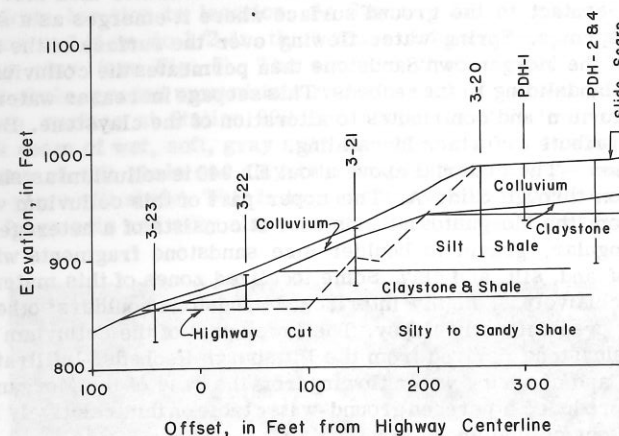
FIG. 4.—GEOLOGIC SECTION THROUGH SLIDE A

Colluvium.—The material above about El. 940 is colluvium as shown in Fig. 4, a section through Slide A. The upper part of this colluvium was derived largely from the Morgantown Sandstone. It consists of a heterogeneous mixture of angular, gravel to boulder size sandstone fragments with variable amounts of and, silt, and clay. Some localized zones of this material consist almost exclusively of highly interlocked sandstone boulders; other localized zones are predominantly clayey. The lower part of the colluvium consists of clay and claystone derived from the Pittsburgh Redbeds. Infiltration of surface water and of spring water flowing from the base of the Morgantown Sandstone has produced a perched ground-water table on this relatively impervious clay-claystone colluvium.

The rocks below about El. 940 are in place. They consist of silty to sandy shales with some thin beds of claystone and sandstone. There was a relatively thin zone of colluvium and weathered rock along the valley wall below about El. 940 before slope excavation began. The colluvium in this zone is believed to have spilled over the edge of in-place shale at approximately El. 940 during the ancient landsliding. The boundaries between colluvium and weathered rock and between weathered rock and unweathered rock in the valley wall below about El. 940 were difficult to determine from the available boring information. The colluvium-rock boundary shown along the valley wall below El. 940 in Fig. 4 is therefore only approximate.

It should be noted that ground surface profiles along both walls of the valley of Kilbuck Run have the characteristic shape of landslide terrain. This is shown by the ground surface profile in Fig. 4. The surface of the colluvium near the top of the cut slope is nearly level. This colluvial bench or terrace is quite consistent on both sides of the valley. It occurs at approximately the stratigraphic level of the Ames Limestone (top of Pittsburgh Redbeds) and marks the upslope extremity of the ancient landslide masses.

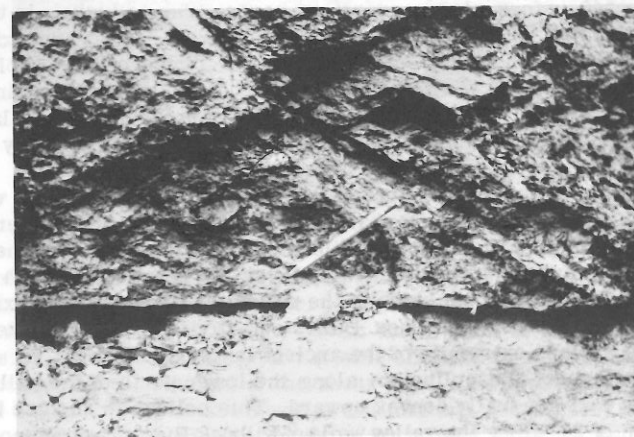
FIG. 5.—PHOTOGRAPH OF SHEAR ZONE AT STATION 928, MAY 20, 1969

Each of the failure surfaces was located in a shear zone from 1 in. to 12 in. thick. Most shear zones were located at the top of in-place silt shale and were generally overlain by claystone colluvium. The exact nature of the shear zone different from location to location. At Station 928, for example, the failure surface was a 1/4-in. to 1/2-in. thick seam of damp, medium-stiff, slicken-sided gray clay (see Fig. 5). The clay, which was underlain by weathered fissile silt shale, graded upward into relatively intact red and gray claystone. The failure surface at Station 909 (the north end of Slide A) consisted of a 2-in. thick seam of wet, soft, gray silty clay (see Fig. 6). It was underlain by a 3-in. zone of silt shale and claystone fragments in a silty clay matrix and then by in-place silt shale. This failure surface was overlain by above 6 in. of claystone fragments and silty clay and above that by fractured claystone.

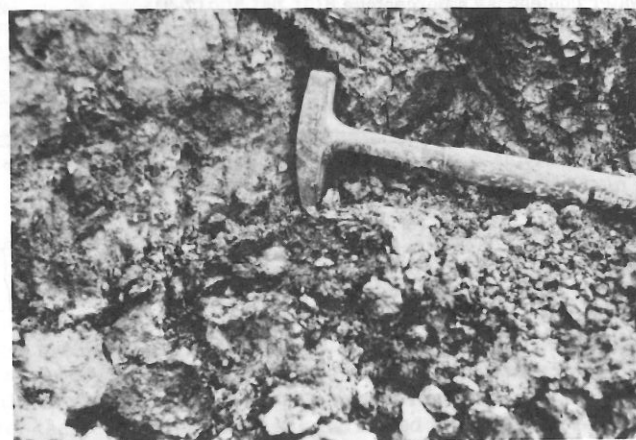
FIG. 6.—PHOTOGRAPH OF SHEAR ZONE AT STATION 909, MAY 13, 1969

Most of the shear zones studied along this section of I-279 were similar to the one at Station 909. They had three definite parts. The actual surface of sliding was generally a 1/4-in. to 2-in. thick seam of damp to wet, soft to medium-stiff, gray silty clay with variable amounts of sand. This seam was usually located near midheight of the shear zone. The parts of the shear zone above and below the clay seam consisted of a mixture of silty clay and angular, sand to gravel size claystone and shale fragments. Though the thicknesses of these upper and lower parts varied considerably from place to place, they were typically 2 in. to 3 in. The platy shaped claystone and shale fragments in the upper and lower parts of the shear zones were commonly aligned parallel to the direction of movement. This is considered a macroscopic manifestation of the parallel particle arrangement reported by Skempton (9) for residual strength behavior. The shear zones were usually damp to wet and frequently showed appreciable seepage.

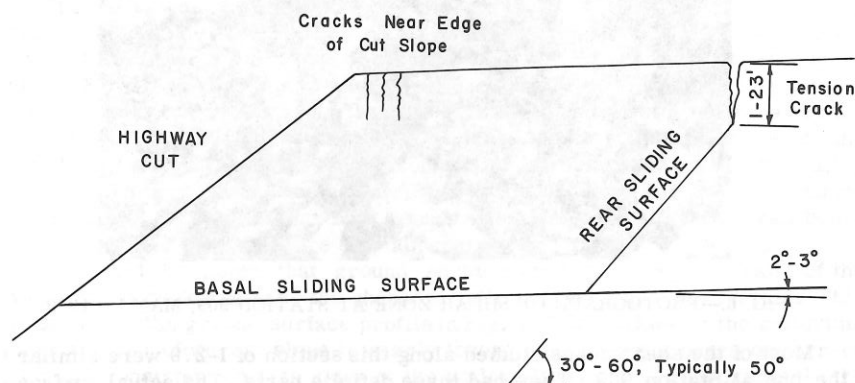
FIG. 7.—SCHEMATIC CROSS SECTION OF TYPICAL FAILURE MASS

Geometric Details.—All slides observed along this section of I-279 were of the sliding wedge type. Each failure surface consisted of three parts as shown in Fig. 7. These parts are a basal surface of sliding, a rear surface of sliding and a tension crack at the ground surface. The basal surfaces of sliding typically dipped 2° or 3° and, as mentioned previously, probably coincided with ancient landslide surfaces near the top of in-place rock.

Where the failure mass moved out into the highway cut, the toe of the mass was sometimes cantilevered as much as 1 ft over the edge of in-place rock. Where the toe material was relatively clayey and plastic, it sometimes bent under its own weight and flowed several inches down over the face of the cut slope before breaking off and falling to the bottom of the cut slope. Definite streamlines were observed in this flowing clay; rock particles in it were generally aligned parallel to these streamlines. Nonplastic toe material simply tumbled over the edge of in-place rock and rolled or slid down the slope. This sliding over the edge of the cut induced flexural-type tensile stresses in the upper parts of the failure masses. Additional tension cracks then formed near the edge of the original cut slope as shown in Fig. 7.

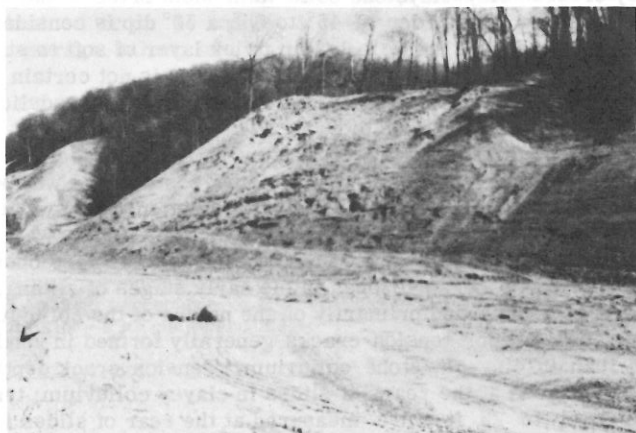
FIG. 8.—PHOTOGRAPH OF CUT SLOPE AT SLIDE A, MARCH 22, 1969

History of Slide.—Excavation began in the vicinity of Slide A on November 26, 1968. The colluvium was excavated at an inclination of 1.25:1 or 39°. Tension cracks were reported above the cut slope between Stations 906 + 50 and 908 + 50 on December 4. This slide was first inspected by the senior writer on December 17 when excavation was down to about El. 920. On December 17 when excavation was down to about El. 920. On December 17, the slide extended from Station 906 + 50 to Station 908 + 50. There was a 3 ft to 5 ft vertical scarp about 100 ft back from the edge of the cut slope between Station 907 and Station 908 and horizontal movement of 3 ft to 4 ft had occurred. A relatively planar sliding surface was exposed at the base of the scarp at Station 908. This surface consisted of red clayey colluvium slicken-

sided from the slide movement. The surface dipped 35° to 45° west (in the direction of the slide movement). There were also many open fissures in the top of the slide mass parallel to the edge of the cut slope. Fig. 8 is a photograph of the cut slope at Slide A.

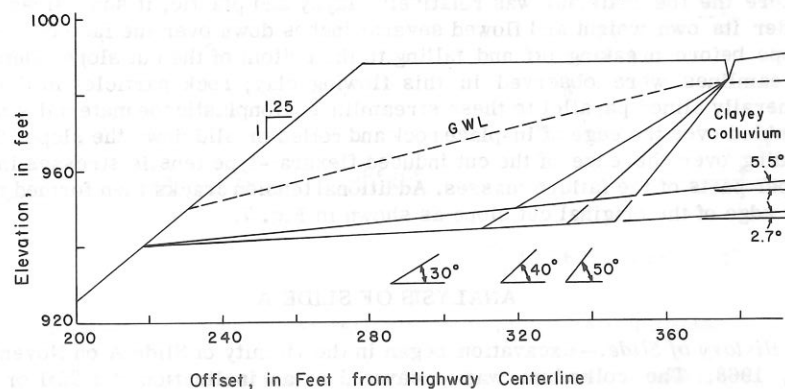
FIG. 9.—IDEALIZED CROSS SECTION THROUGH SLIDE A

slide. This idealized slope cross section is shown in Fig. 9.

Two basal surfaces of sliding were assumed for the stability analyses. Both intersect the slope face at El. 940, the observed elevation of the failure surface outcrop. The lower basal surface of sliding has an inclination of 2.7°. It follows what is believed to be an ancient landslide surface at the base of the clay-claystone colluvium. The upper basal sliding surface has an inclination of 5.5°. It is located near the top of the clay-claystone colluvium at what may also be an ancient landslide surface.

A 5-ft tension crack was assumed to exist at the rear of the slide mass. Rear sliding surfaces of three different inclinations (30°, 40°, and 50°) were drawn from the bottom of this tension crack to the basal surfaces of sliding.

The ground-water level (GWL) shown in Fig. 9 is that corresponding to steady state seepage. It is based on springs observed at El. 950 in the slope face and the average water elevation of 982 observed in boring PDH-2 over the period from February to June, 1969. Boring PDH-2 pinched off near the failure surface of Slide A so water levels observed in it correspond to the perched water table above the failure surface. This ground-water level shown in Fig. 9 is considered a good estimate of ground-water conditions in the failure mass at the time of failure.

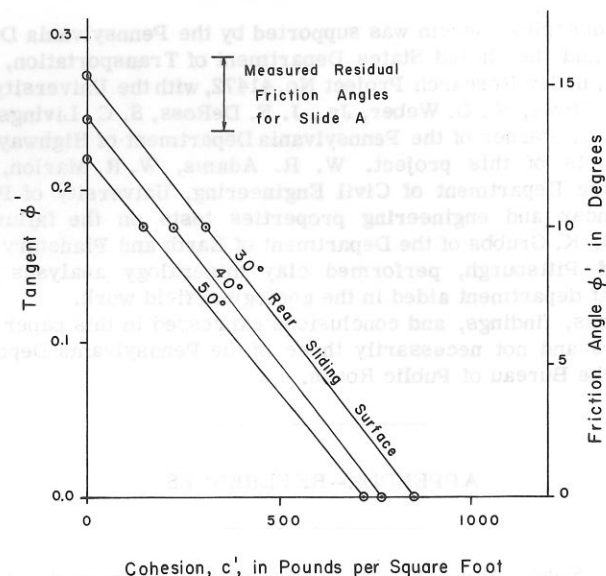
FIG. 10.—CALCULATED TAN ϕ' VERSUS c' FOR SLIDE A

The values of ϕ' required for limiting equilibrium with $c' = 0$ and the values of c' required with $\phi' = 0$ were calculated along with the values of c' required with $\phi' = 10^\circ$. These calculated values are given in Table 2. Values of $\tan \phi'$ versus c' for the 2.7° basal sliding surface are plotted in Fig. 10. The $\tan \phi'$ versus c' values for the 5.5° basal sliding surface are not plotted in that figure as they fall within the range of $\tan \phi'$ versus c' plotted for the 2.7° basal sliding surface.

The friction angles of 12.5° to 15.5° calculated for Slide A are in excellent agreement with the measured residual friction angles of the failure surface material (see Fig. 10). The fact that a residual-level strength was mobilized in the slide is consistent with the geologic history of the site. Movements in the ancient landslides were of sufficient magnitudes to reduce the strengths of the failure surface materials to residual levels. It is believed that the failure surfaces did not heal following the ancient landslides and that residual or near
