JOURNAL OF THE GEOTECHNICAL ENGINEERING DIVISION

REMEDIAL TREATMENT EXPLORATION, WOLF CREEK DAM, KY

By Marvin D. Simmons¹

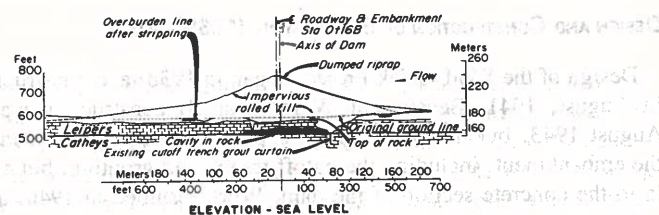
FIG. 8.—Cross Section of Embankment near Concrete Section

constructed from the stratified alluvial deposits in the flood plain both upstream and downstream of the dam site. The more than 10,000,000 cu yd (7.65×10^6 m³) embankment has a top elevation of 773 (235.8 m); side slopes range from 1V on 2H, to 1V on 3 - 1/2H, with 1V on 10H random fill berms at both the upstream and downstream toes (Fig. 8). The embankment is composed primarily of a low to medium-plasticity clay; it contains lesser amounts of silty sand and high-plasticity clay.

The trench had a minimum bottom width of 10 ft (3 m) and was backfilled with lean clay, the same type of material as comprised the embankment. As a result of constructing the cutoff within a system of solution features, very irregular and sometimes vertical and overhanging side slopes resulted and were left in place. At some locations, the bottom of the trench was as much as 60 ft (18.3 m) below top of rock. In general however, the depth of the trench was about 45 ft (13.7 m) below top of rock for the first 1,500 ft (457.5 m) from its tie-in with the concrete section of the dam. A large number of stratified silt-filled solution channels and caves intersected the trench on both upstream and downstream sides. These features followed the orientation of the joint sets present in the area (Fig. 4) and received no special treatment during construction.

(15.3 m), which resulted in the bottom of the grout curtain being very irregular and not penetrating to any constant elevation or stratigraphic horizon. Since the grouting was performed from the bottom of the cutoff trench, most of the solution features that would have accepted large quantities of grout were never encountered—they were above this level. All grout holes were cored 2 in. (50.8 mm) in diameter and angled toward the right abutment at about 12 degrees from vertical. Primary holes were drilled and grouted on 10 ft (3 m) centers and split-spaced to 5 ft (1.5 m) centers, if the adjacent hole took more than 10 sacks of cement.
