JOURNAL OF THE GEOTECHNICAL ENGINEERING DIVISION

Lateral Loading of Deep Foundations in Stiff Clay

By H. Bolton Seed,¹ Kenneth L. Lee,² Izzat M. Idriss,³ Members, ASCE,
and Faiz I. Makdisi,⁴ A. M. ASCE

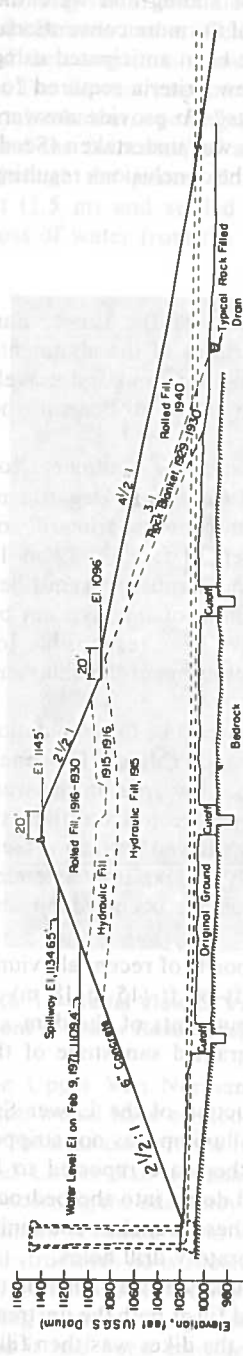
FIG. 2.—Cross Section of Lower San Fernando Dam (Los Angeles Department of Water and Power) (1 ft = 0.305 m)

Construction of Lower San Fernando Dam.—Construction of the Lower San Fernando Dam (Fig. 2) began in 1912. The foundation alluvium was not stripped off prior to placing the embankment fill. However, there are reported to be three cutoff trenches through this alluvium that extend down into the bedrock, and which were backfilled with puddled clay. One of these trenches containing plastic clay was encountered in one of the recent exploratory drill holes.

Judging by the available early photographs, the embankment was constructed by first making a broad dike of wagon-dumped and rolled fill at both the upstream and downstream edges. The large central area between the dikes was then filled by standard hydraulic fill procedures. Unfortunately, the lateral and vertical

Thus, the dam can best be described as essentially a hydraulic fill embankment capped by a potpourri of wagon-dumped and rolled fills, founded on alluvium with three cutoff trenches to bedrock, and with a 20-ft (6-m) downstream berm at El. 1,096 (334 m). It has an upstream slope of 2-1/2:1, downstream slopes of 2-1/2:1 and 4-1/2:1, a height of 142 ft (43 m), a crest width of 20 ft (6 m), and a length of 2,080 ft (634 m). It was faced upstream with lightly reinforced concrete and had a 3-ft (0.9-m) high concrete parapet wall at the upstream edge of the crest. Altogether, about 3,300,000 cu yd (2,500,000 m³) of embankment were used in construction to impound 20,500 acre-ft (25,300,000 m³) of water.

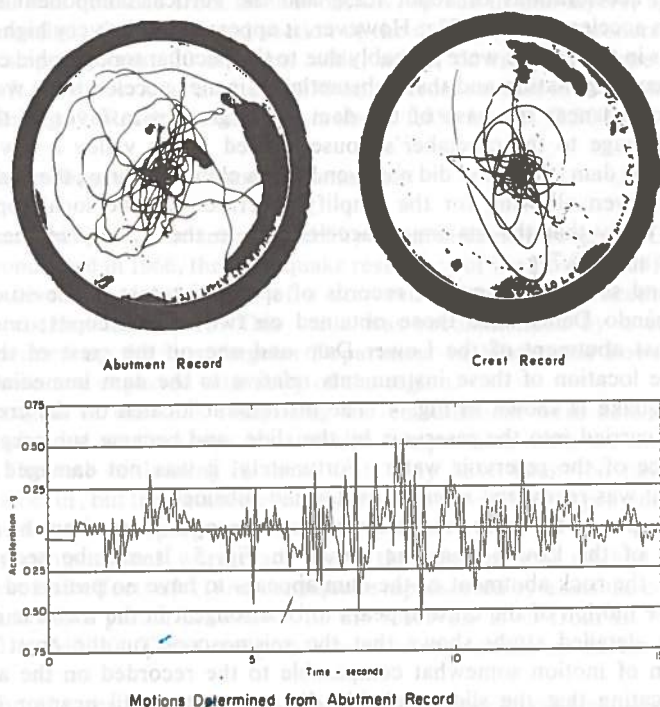
FIG. 5.—Seismoscope Records at Lower San Fernando Dam during Earthquake of February 9, 1971

Photographs of the traces made by the seismoscopes located on the abutment and crest of the Lower Dam are shown in Fig. 5. It may be seen that the motion of the rock abutment of the dam appears to have no preferred direction whereas the motion of the crest appears to be strongest in the traverse direction. However, detailed study shows that the seismoscope on the crest recorded a duration of motion somewhat comparable to the recorded on the abutment, thus indicating that the slide probably did not occur until near or just after the end of the stronger earthquake motions.

record from the east abutment has been made by Scott (1973), who observed that some of the small regular waves on the trace were a peculiarity of the instrument and not of the earthquake. These waves provided a time scale to the record, from which it was possible to convert the trace on the seismoscope into a time history of acceleration, as shown in the lower part of Fig. 5. Some uncertainties developed where the instrument reached its maximum travel and bounced against its support, and where in several instances, the pen went off scale. Allowing for the uncertainties involved, Scott suggested that the peak acceleration developed should probably be no greater than 0.55g-0.6g. An independent analysis by Duke et al., indicated a maximum acceleration in the rock abutment at the damsite of about 0.5g with no significant amplification or attenuation between the rock and the crest of the dam.

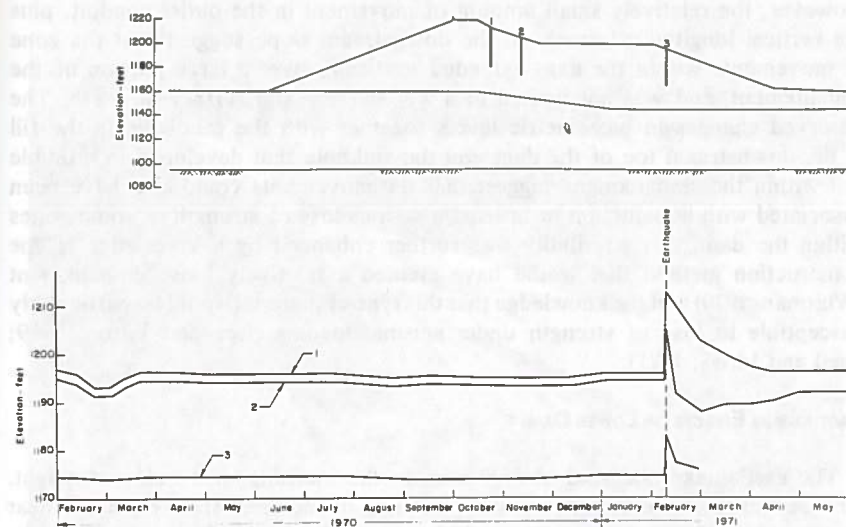
FIG. 9.—Changes in Water Level in Piezometers Following Earthquake, Upper San Fernando Dam (1 ft = 0.305 m)

Of special interest in studying the causes of the movements described were the observations of water level in three piezometers that had been installed in the dam for surveillance purposes prior to the earthquake. The locations of these piezometers in the cross section and the water-level changes following the earthquake are shown in Fig. 9. The effect of the shaking was to cause an immediate increase in pore-water pressure in the embankment, which slowly dissipated with time following the earthquake. As may be seen from Fig. 9, the recorded changes in pore pressure ranged from 8.5 ft-17 ft (2.6 m-5.2 m) of water. However, the increases for piezometers 1 and 2 near the center of the embankment were so large that water spilled over the tops of the well casings and the maximum values could therefore not be measured. Furthermore, since the first observations on these piezometers were made about 24 hr after the earthquake occurred, the actual increase in pore-water pressure in piezometer 3 is likely to be substantially higher than that shown.

The field observations at the Upper Dam suggest that the movements were due to increases in pore-water pressure and a corresponding weakening of the soil within a large portion of the dam. Near the top of the upstream face these movements appeared to be concentrated in two or three well-defined slip surfaces. However, the relatively small amount of movement in the outlet conduit, plus the vertical longitudinal crack on the downstream slope suggest that the zone of movements within the dam extended vertically over a large portion of the embankment, and was not limited to a well-defined slip surface at depth. The observed changes in piezometric levels together with the sandboils in the fill at the downstream toe of the dam and the sinkhole that developed in erodible soil within the embankment suggest that the movements could also have been associated with liquefaction or at least a serious loss of strength of some zones within the dam. This possibility was further enhanced by a knowledge of the construction method that would have created a relatively loose embankment (Whitman, 1970) and the knowledge that this type of material would be particularly susceptible to loss of strength under seismic loading (Lee and Fitton, 1969; Seed and Idriss, 1971).

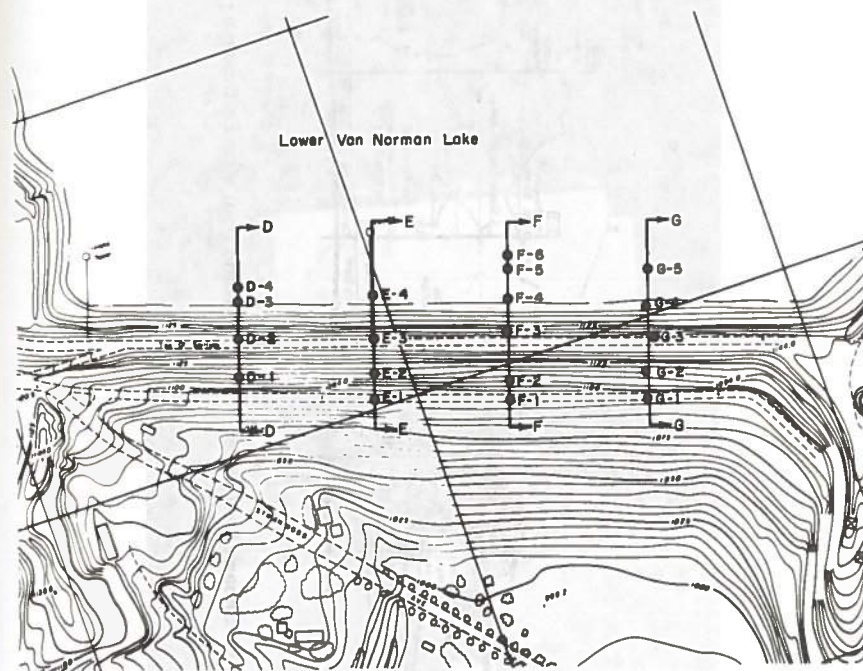
FIG. 16.—Plan of Lower San Fernando Dam

A plan view of the Lower Dam, showing the location of these 19 holes is presented in Fig. 16. A typical cross section of the central portion of the dam where the trench section was located is shown in Fig. 17. The section shows in dashed outline the original profile of the dam, and in bold outline the surface profile of the dam as it was surveyed after the slide and after the water in the reservoir had been removed. An abbreviated log for each of the drill holes is also shown on the section.

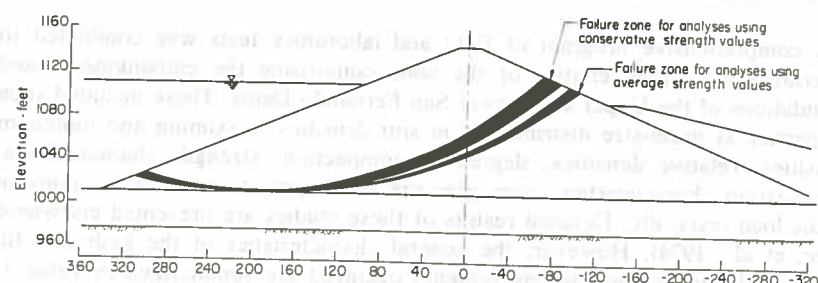
FIG. 19.—Failure Zones Indicated by Pseudostatic Stability Analyses, Lower San Fernando Dam (1 ft = 0.305 m)

The critical surfaces of sliding determined by the analyses are shown in Fig. 19 and the computed factors of safety for different seismic coefficients as determined by the conventional method of slices, are presented in Table 2. It may be seen that the computed locations of the most critical sliding surface are in reasonably good agreement with the position of the slide zone in the embankment, and that the analyses correctly indicate that failure would not extend into the foundation soils. However, for a seismic coefficient of 0.15, the computations indicate factors of safety ranging from about 1.22 for a conservative interpretation of the test data combined with a Mohr envelope method of data use, to about 1.61 for an average interpretation of the test data combined with the use of the τ_{ff} versus σ_{fc} strength relationship.

Embankment Strength Characteristics		Data form used in analysis (3)	Factor of safety for seismic coef- ficient, $k = 0.15$ (4)	Seismic coefficient, k , for factor of safety = 1 (5)
c , in pounds per square foot (1)	ϕ , in degrees (2)			
(a) Lower San Fernando Dam				
1,200	20	Mohr envelope	1.22	0.22
1,200	20	τ_{ff} versus σ_{fc}	1.37	0.25
2,040	19	Mohr envelope	1.47	0.29
2,040	19	τ_{ff} versus σ_{fc}	1.61	0.34
(b) Upper San Fernando Dam				
1,100	24	Mohr envelope	2.03	0.43
1,400	28	τ_{ff} versus σ_{fc}	2.49	0.55

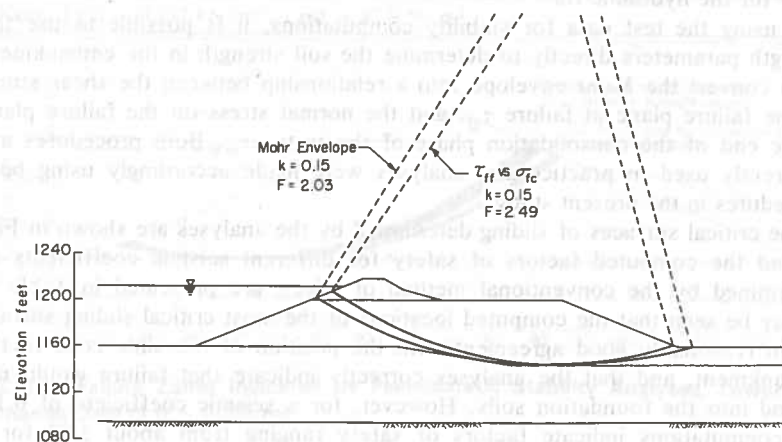
FIG. 20.—Results of Pseudostatic Analyses of Embankment Stability, Upper San Fernando Dam (1 ft = 0.305 m)

were made for the Upper San Fernando Dam. The strength parameters for consolidated-undrained triaxial compression tests for the embankment and foundation soils of this dam (Lee, et al., 1974) were: (1) Embankment— $c = 1,100$ psf (52.7 kN/m²), $\phi = 24^\circ$; and (2) foundation— $c = 1,420$ psf (68 kN/m²), $\phi = 32^\circ$. The results of the pseudostatic analyses are shown in Fig. 20 and Table 2. The computed position of the critical sliding surface (Fig. 20) is again in reasonable agreement with the observed behavior of the embankment during the earthquake, in that downstream movement occurred with the formation of scarps on the upstream face in approximately the same position as that indicated by the analysis. However, for a seismic coefficient of 0.15, the computed factor of safety was about 2.0 for soil strengths determined from a standard Mohr envelope and 2.5 for strengths determined from the τ_{ff} versus σ_{fc} form of data representation. In either case the analysis indicates an ample margin of safety against slide movements developing—a result in marked contrast to the actual behavior of the embankment.

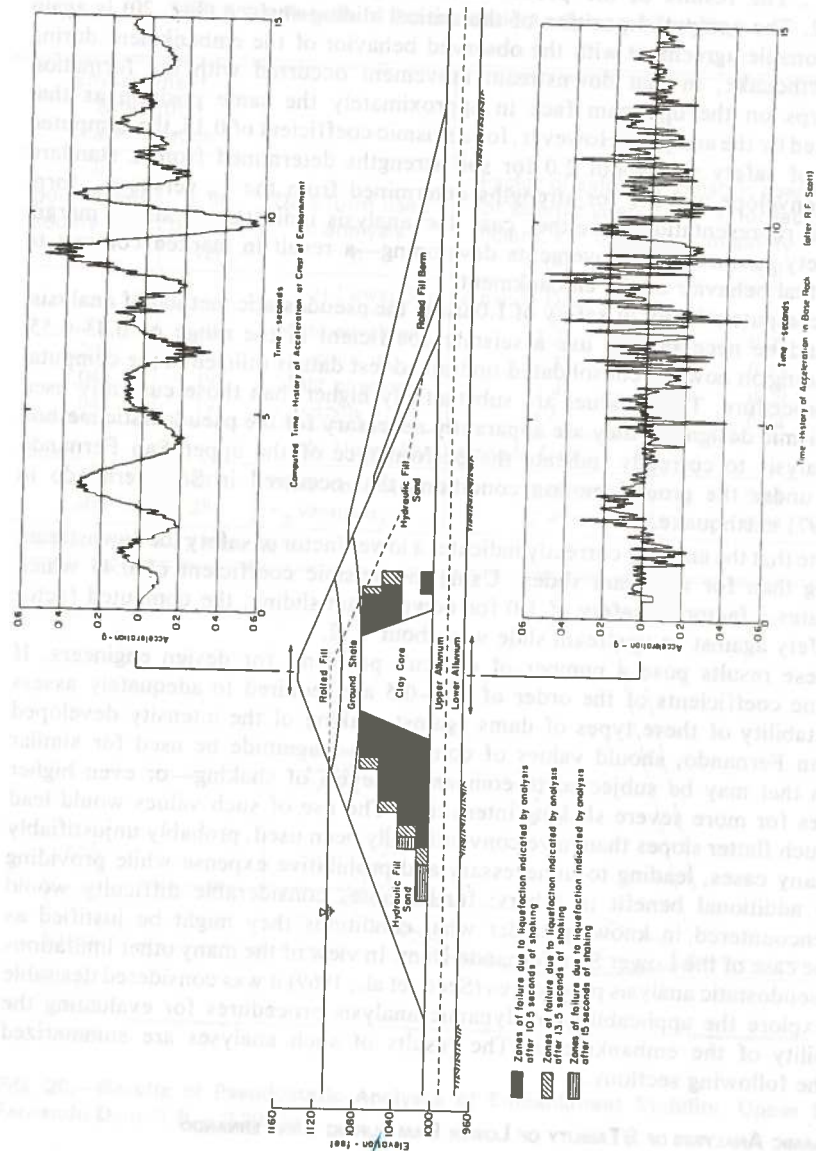
FIG. 21.—Analysis of Response of Lower San Fernando Dam during San Fernando Earthquake to Base Motions Determined from Seismoscope Record (1 ft = 0.305 m)

The results of the analysis of the Lower Dam are summarized in Figs. 21 and 22. Fig. 21 shows the time history of base excitation determined by Scott from the seismoscope record and the computed time history of crest accelerations corresponding to the embankment response. Note that the computed maximum acceleration at the crest is similar to that at the base, as previously indicated by the seismoscope records. The figure also shows the zones where the combination of initial static stresses and induced dynamic stresses would lead to the development of high pore-water pressures and large strains. In fact, the analysis showed that within the shaded area of the embankment the residual pore-water pressures would be equal to the overburden pressure and strains

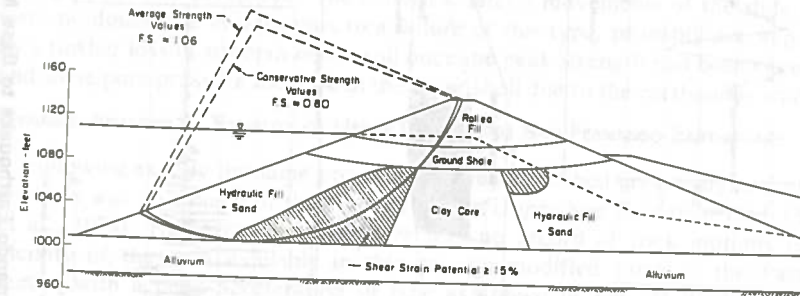
FIG. 22.—Analysis of Stability of Lower San Fernando Dam after Development of Zone of High Strain Potential (1 ft = 0.305 m)

ranging from 5%–30% would tend to occur. The zone in which shear strain would be particularly high (exceeding 15%) is shown in Fig. 22. If it is considered that the soil in this zone would provide no effective resistance to slide movements in the embankment (as a result of liquefaction and the development of high pore-water pressures during the earthquake), a stability analysis can be made to assess the stability of the slope against static failure, as shown in Fig. 22. Using average consolidated-undrained strength parameters because of the sudden change in stress distribution, the computed factor of safety along the critical sliding surface shown in Fig. 22 is about 1.06; using conservative values of strength parameters, the computed factor of safety is about 0.8.

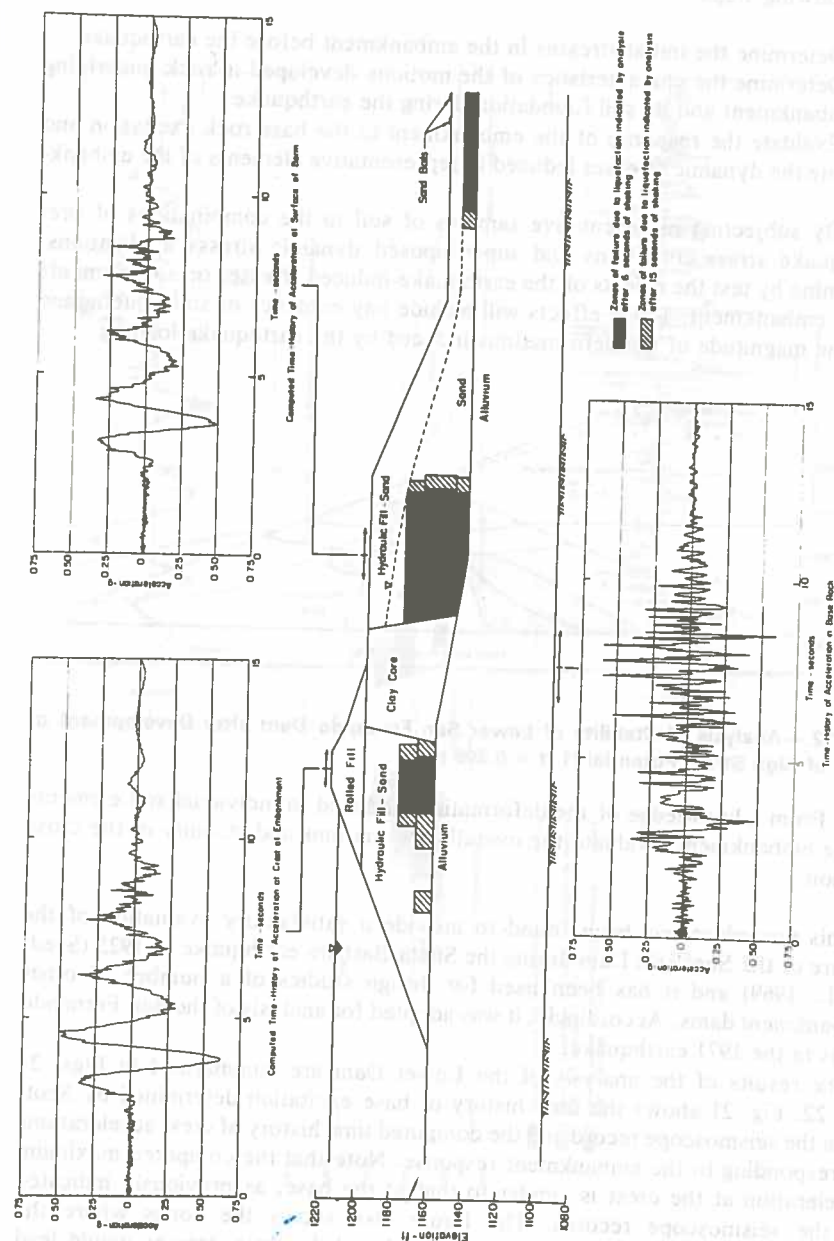
FIG. 23.—Analysis of Response of Upper Dam during San Fernando Earthquake to Base Motions Determined from Modified Pacoima Record (1 ft = 0.305 m)

Following exactly the same procedure as that described previously, a dynamic analysis was also made of the stability of the Upper San Fernando Dam (Seed, et al., 1973). However, because there was no record of rock motions in the vicinity of the dam available in this case, a modified form of the Pacoima record with a peak acceleration of 0.6g as shown in Fig. 23 was considered to be an appropriate representation of the probable base excitation.

The results of the analysis are summarized in Fig. 23 which shows the computed accelerations at the crest and downstream berm of the embankment and the zone in which liquefaction and strains exceeding 5% would be computed to occur. Following the same procedure as before and considering the zone where computed shear strains exceed 15% to make no contribution to the overall embankment stability, the factor of safety against a downstream slide was computed to be about 1.75. Thus, despite the extensive zone of liquefaction or high pore pressure developed by the earthquake shaking, the embankment would easily be able to withstand the small inertia forces developed later in the earthquake, together with the static stresses, without developing a residual downstream instability condition.
