JOURNAL OF THE SOIL MECHANICS AND FOUNDATIONS DIVISION

FAILURE OF COLLUVIAL SLOPE

By James V. Hamel,¹ A. M. ASCE and Norman K. Flint²

REFERENCE: Hamel, James V., and Flint, Norman K., "Failure of Colluvial Slope," *Journal of the Soil Mechanics and Foundations Division*, ASCE, Vol. 98, No. SM2, Proc. Paper 8731, February, 1972, pp. 167-180

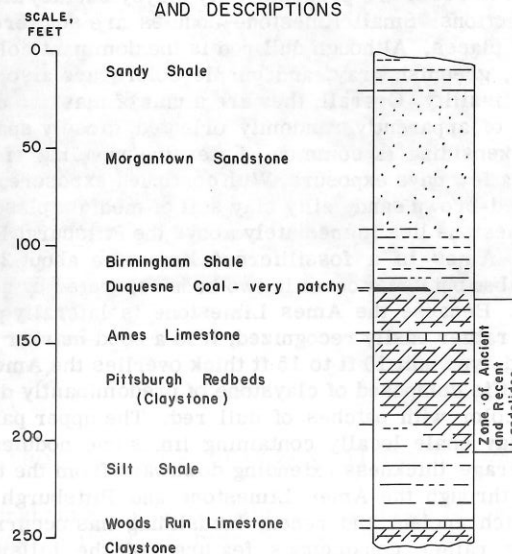
FIG. 3.—STRATIGRAPHIC SECTION

The part of the stratigraphic section of particular interest at the slide site is shown in Fig. 3. An unnamed silt shale (above the Woods Run Limestone) lies at the base of this sequence. This silt shale ranges from 35 ft to 50 ft in thickness. The lower part contains thin interbedded sandstone layers; the upper part is composed of thin-bedded silt shale. The Pittsburgh Redbeds lying directly above this silt shale represent a weak zone of claystone 40 ft to 60 ft thick which has participated in extensive landsliding (both ancient and recent) in the study area. The failure surfaces of the landslides along I-279 all occurred at or slightly above the contact between these redbeds and the silt shale.
