JOURNAL OF THE GEOTECHNICAL ENGINEERING DIVISION

PROCEEDINGS OF
THE AMERICAN SOCIETY
OF CIVIL ENGINEERS

FIG. 1.—Aguada Blanca Dam—Area Plan

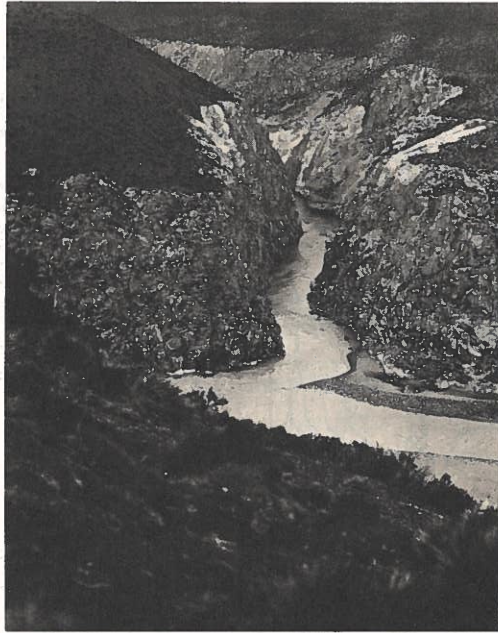
FIG. 3.—Aguada Blanca Canyon Seen from Upstream Prior to Damming; On Left Bank, Ignimbrite Appears Covered by Dark Piroclasts

The upper reservoir is a narrow V shaped valley while the lower half, where a few creeks meet the Rio Chili, is considerably wider. At the lower reservoir end, the river, whose path has steadily been southbound, suddenly turns west cutting through a rock rift and enters a narrow canyon named Boquilla de Aguada Blanca, shown in Fig. 3.
